Mobile Intel[®] Pentium[®] II Processor Specification Update

Release Date: October 2005

Order Number: 243887-049

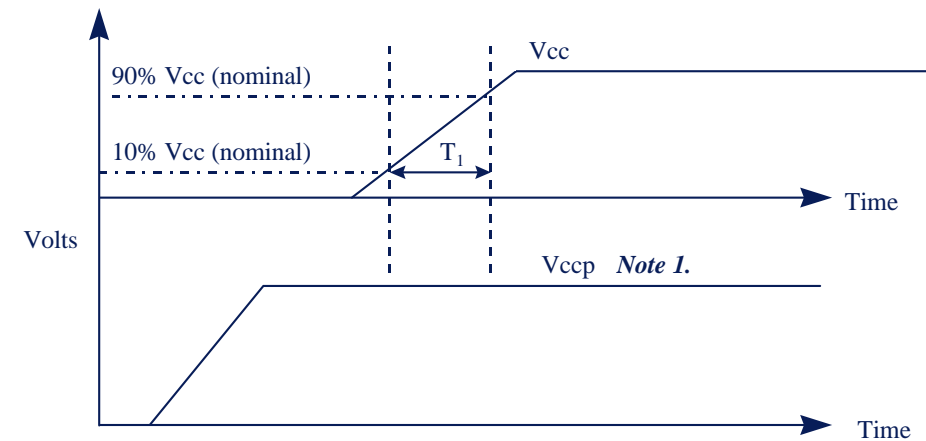
Figure 1. V_{CC}/V_{CCP} Timing Requirements (Mobile)

Problem: The processor uses the PWRGOOD signal to ensure that no voltage sequencing issues arise; no pin assertions should cause the processor to change its behavior until this signal is asserted, when all power supplies and clocks to the processor are valid and stable. However, if V_{CC} ramps up before V_{CCP} , it will cause the processor to enter an invalid state.

Implication: If this erratum occurs, the system may boot normally however, the L2 cache may not be initialized.

Workaround: For Mobile Pentium II processors, ensure that V_{CC} ramps after or with the L2 cache IO voltage (V_{CCP}). If V_{CCP} ramps after the V_{CC} , a delay circuit can be placed on the core V_{CC} to ensure that V_{CC} ramps at the same time or after V_{CCP} as shown below in Figure 1.
